Longhorn Council, Boy Scouts of America, Viking Long Ship Restoration

Prepared by David Kanally, Wooden Boat Association, March 24, 2018

Viking Long Ship restoration details

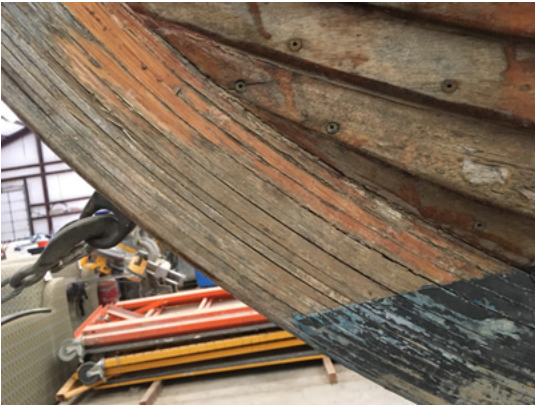
Stem and Keel Lamination: The keel and stem are laminated, and many of the seams have opened up between the layers. These should be filled and sealed with West System Epoxy thickened with low-density filler, stained with oak colored stain (do not use caulk for this step).

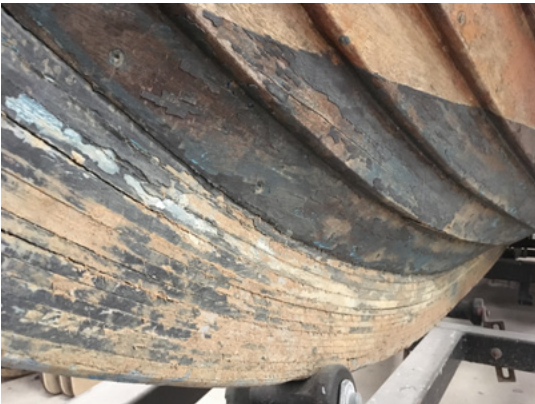
Bottom lapstrake seams: Do a thorough job of reefing out the seams so the new caulk has a place to enter the seam and seal. Use a reefing hook (you can make one by bending the tip of an awl into a hook shape).

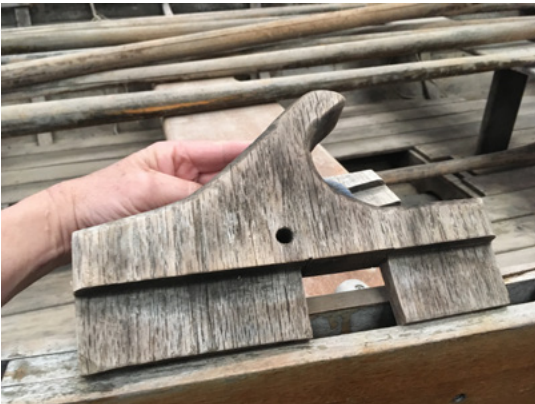
Oar locks: The oar locks are made of oak and are traditionally short-lived due to the pressure they endure. Consider using purple heart or other hardwood in the place of oak, and creating more of a hump on the top of the lock to give more strength to the piece.

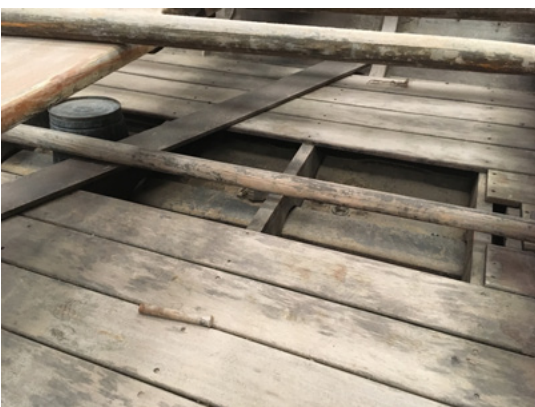
Mast step location. This spot in the floor is where the mast step goes (see first two photos on next page) There are two trim planks that drop into the spaces on each side of the mast step.

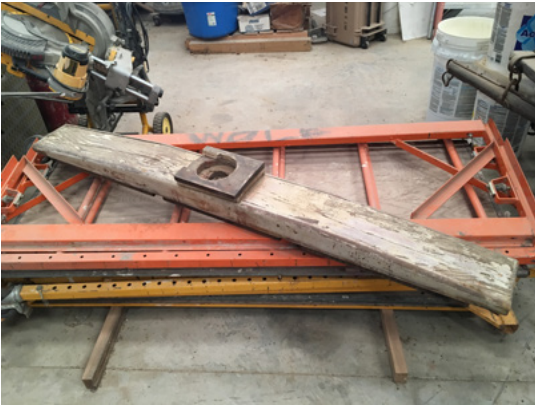
Mast step assembly. The mast step log is in good shape, but should be sanded and sealed with CPES and varnished.

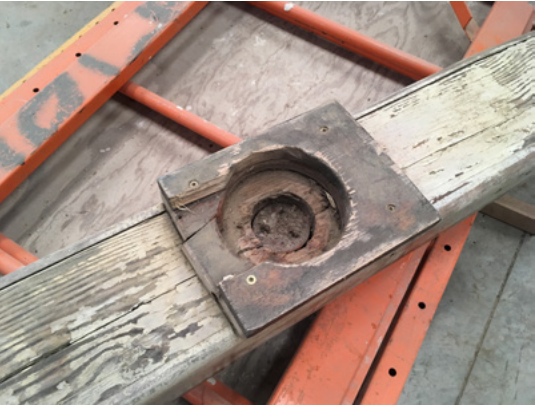
The plates on the top of the mast step with the round hole to accommodate the mast should be remade in marine plywood to avoid the chronic split-out problem.

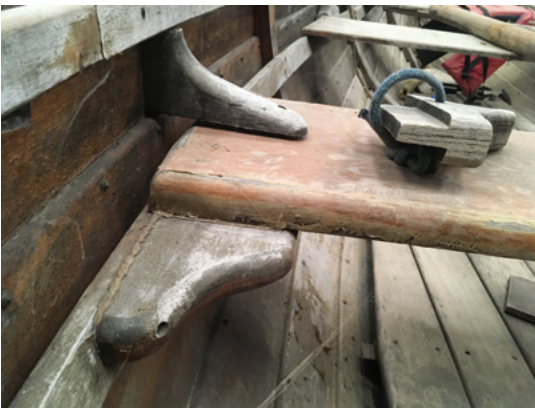
The seat braces themselves are in good shape. There is one broken knee (top brace). All should be removed and refastened more securely. Consider moving the knee to a supporting position under the bracket.

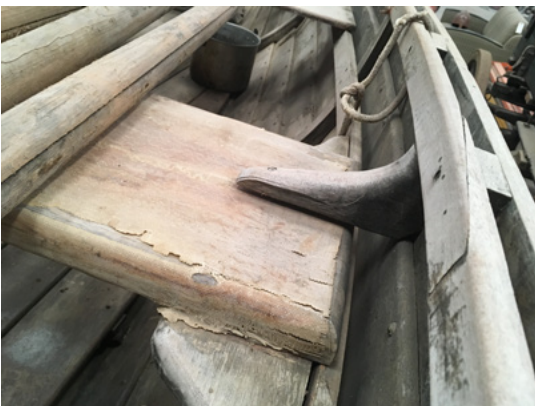
The seat brace and knee on the starboard side of the mast support seat are completely detached. They need to be removed and refastened more securely. Consider moving the knee to a supporting position under the bracket.

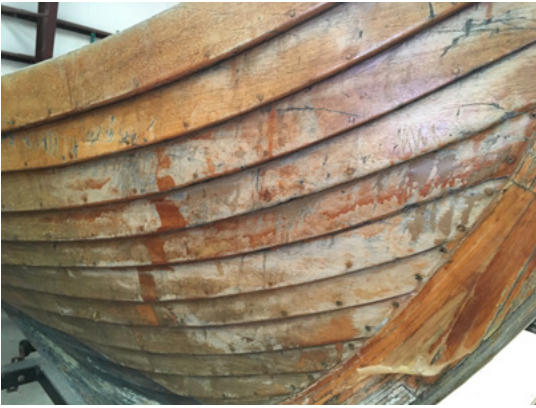
The clinker nails holding all the planks together have exposed heads, so be careful while stripping, scraping or sanding the planks so as not to damage the nail heads

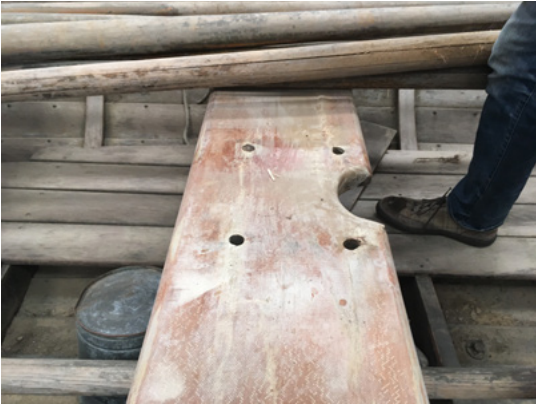
There is a U-shaped bracket missing that is designed to hold the mast in the notch in the middle seat. The bottom of the “U” holds the back side of the mast and the top members of the “U” are secured to the seat by driving pegs through holes into the holes in the seat. Suggest using 1” thick marine mahogany plywood to make the new bracket to avoid splitting problem (WBA may have a piece of plywood in stock for this.)

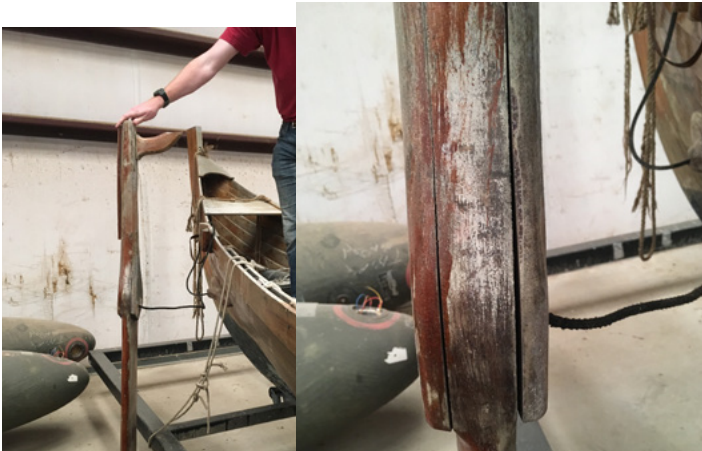
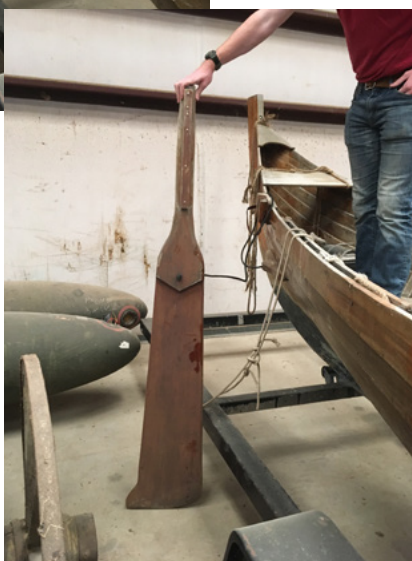
The steering oar (rudder) requires regluing of seams and the fabrication of a new handle. It is otherwise in good shape, but needs to be stripped, sanded, sealed and varnished.

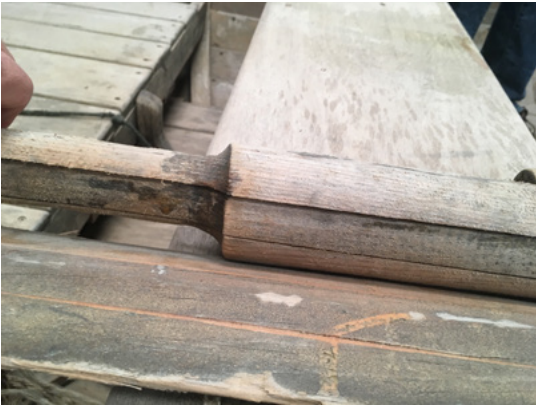
The eight oars are glue-ups with three pieces laminated together. Seams need to be re-glued and clamped, then the oars should be sanded (lots of splinters here!), sealed and varnished.

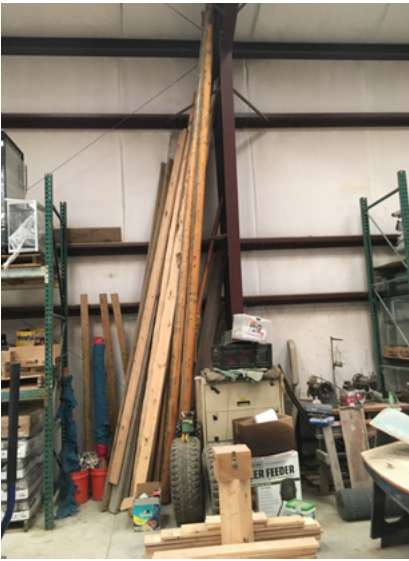
The masts are approximately 25 feet in length and are of hollow construction. The masts should first be stripped. Then, the seams need to be filled with thickened, stained epoxy, then the masts need to be sanded, sealed and varnished. There is also a yardarm (boom) of solid construction requiring similar treatment.
